**DURABILITY OF
REINFORCED AND
POST-TENSIONED
CONCRETE STRUCTURES**

Problems and Solutions

DURABILITY OF REINFORCED AND POST-TENSIONED CONCRETE STRUCTURES – PROBLEMS AND PROGRESS

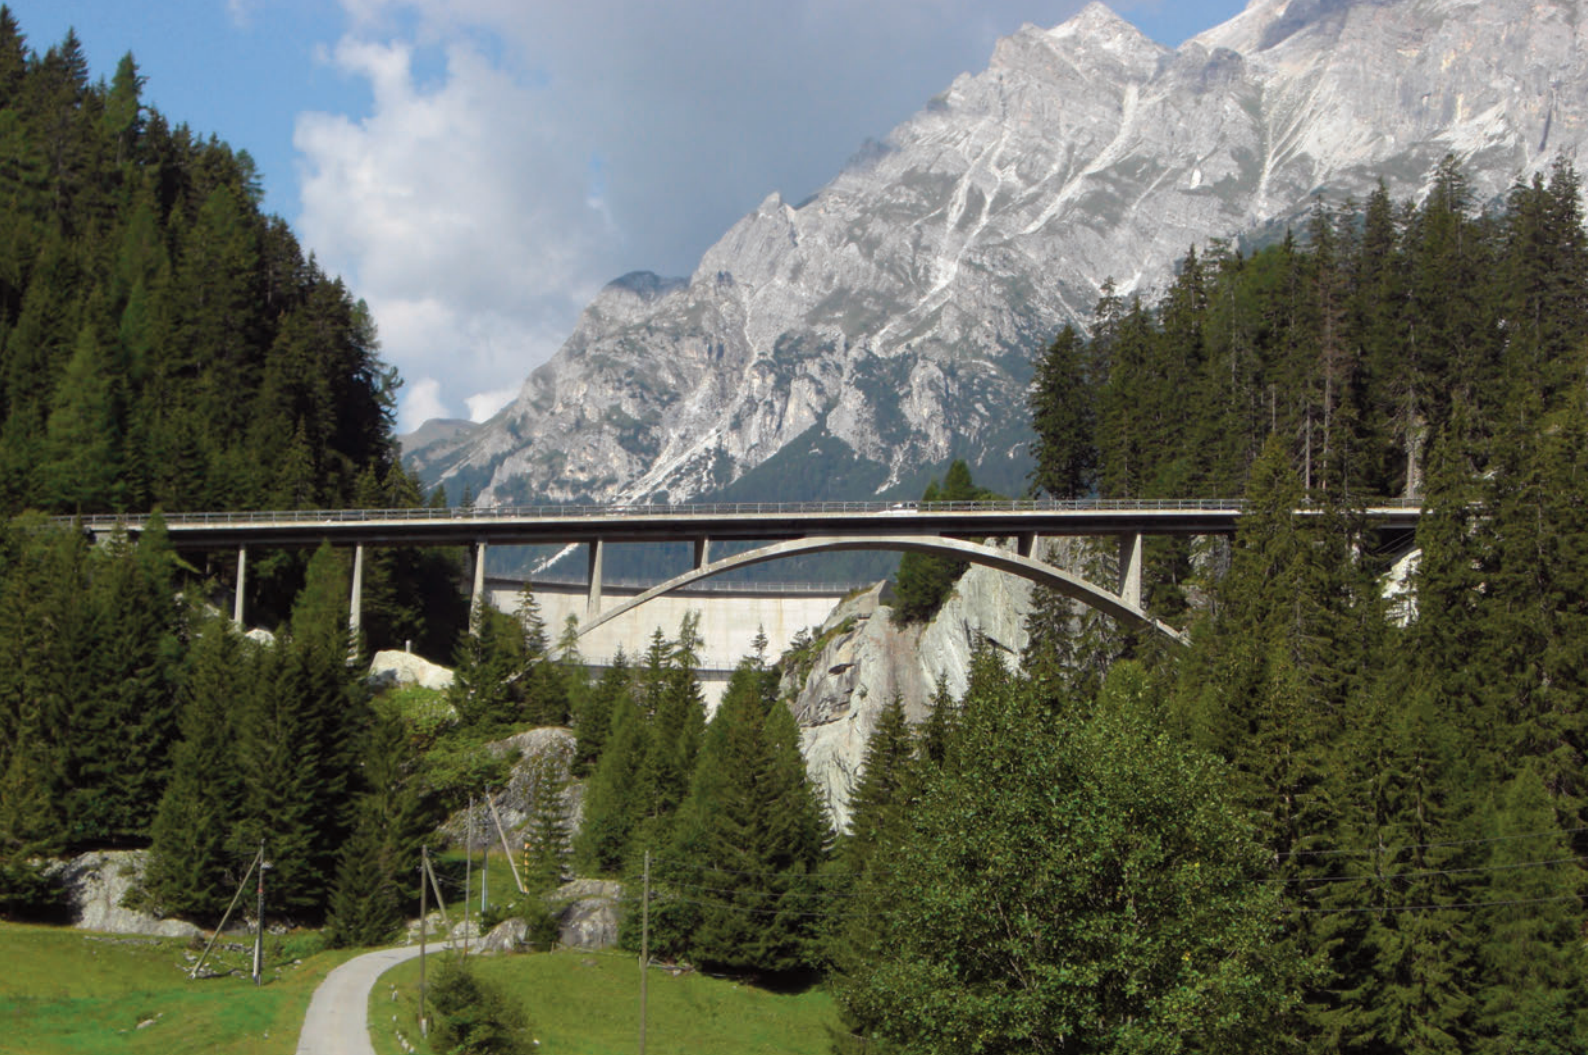
figure 2

A detailed study on the cost of corrosion in industry (figure 2) was conducted by NACE in 1998 for the USA [2]. Infrastructure in the NACE study was divided into the following sectors: highway bridges, gas and liquid transmission pipelines, waterways and ports, hazardous materials storage, airports, and railroads. The total annual direct cost in the category “infrastructure” was estimated to be \$22.6bn.

From the approximately 583,000 highway bridges in the U.S. about 15% are structurally deficient because of corroded steel and steel reinforcement. Annual direct cost estimates total \$8.3bn, including \$3.8bn to replace deficient bridges over the next 10 years, \$2bn for maintenance and capital costs for concrete bridge decks and \$2bn for their concrete substructures, and \$0.5bn for maintenance painting of steel bridges. Indirect costs to the user, such as traffic delays and lost productivity, were estimated to be as high as 10 times that of direct corrosion costs. Today, it is estimated that the numbers in the NACE corrosion study in 1998 approximately can be doubled [3].

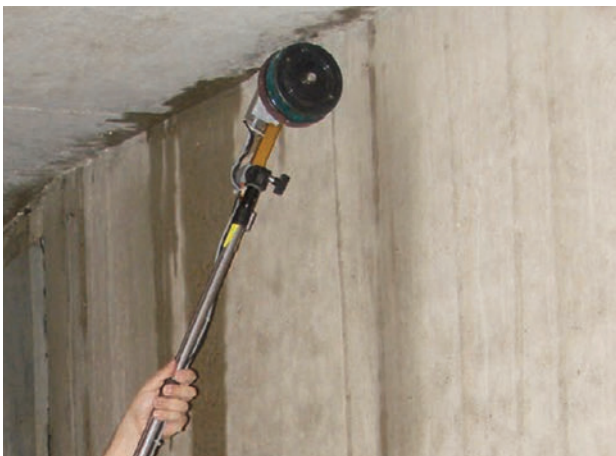
figure 5

in concrete structures ^[6]. A reference electrode, also in the form of a wheel electrode has to be put on the concrete surface (figure 5). A RILEM recommendation was published ^[5] where the experience with potential mapping was incorporated. Several national guidelines describe the procedure and interpretation of half-cell potential measurements.

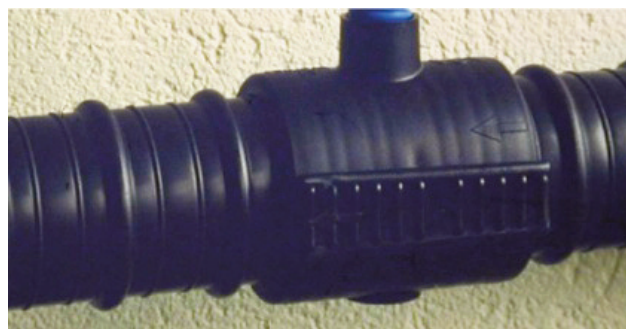
figure 8

To overcome this problem industry has developed new tight plastic ducts for bonded post-tensioning tendons (figure 8) that greatly improve corrosion protection of the steel [9]. Together with electrically isolated anchorages (figure 9), EIT tendons that are protected against corrosion and are easy to monitor can be achieved. Thus for any individual tendon in a structure the degree of corrosion protection of the high-strength steel can be assessed by simple non-destructive measurements at any time (figure 10). This allows a long-term monitoring

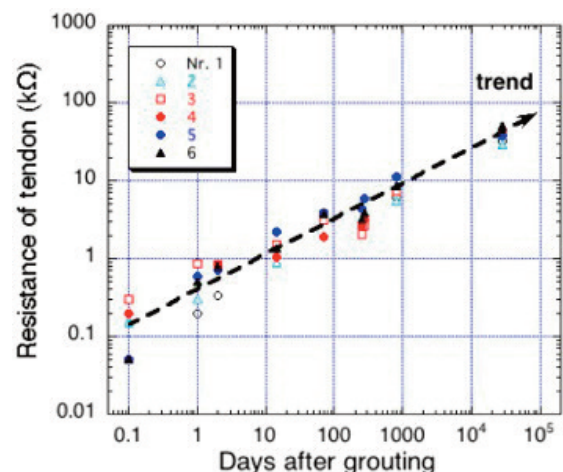
figure 10

of every individual tendon; a decrease of the resistance indicates the ingress of water (and chlorides) at a defect of the duct – long before damage has occurred.
