DURABILITY CHALLENGES

FOR NEW REINFORCED
CONCRETE STRUCTURES MADE
OF BLENDED CEMENTS WITH
REDUCED CO₂ FOOTPRINT

ETH Zurich IfB Prof. Dr. B. Elsener

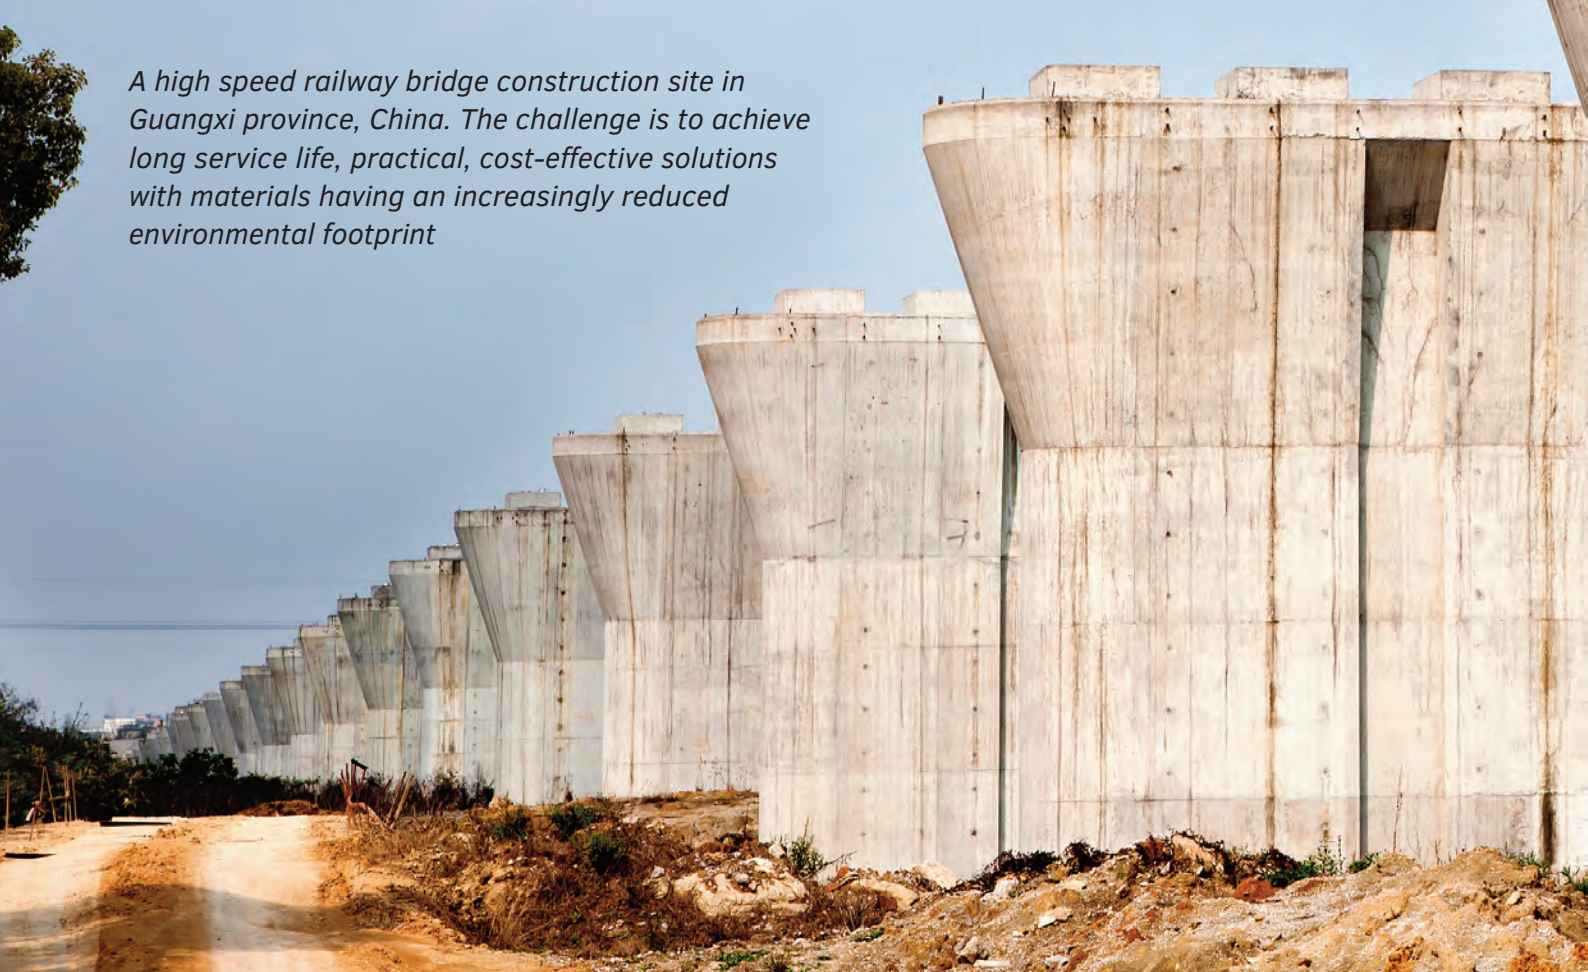
A high speed railway bridge construction site in Guangxi province, China. The challenge is to achieve long service life, practical, cost-effective solutions with materials having an increasingly reduced environmental footprint

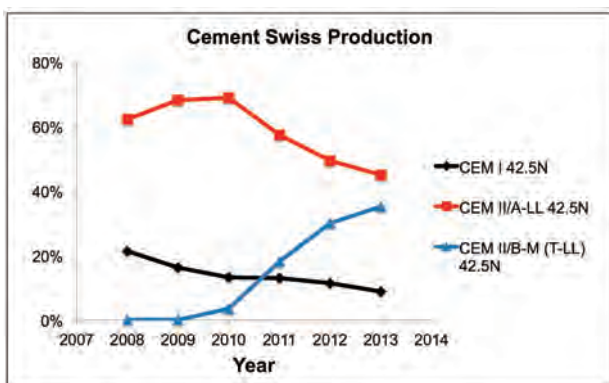
figure 5. Cement consumption showing the continuous decrease of Portland cement (CEM I)

This ongoing substitution is reflected in the decreasing amount of Portland cement (CEM I) and the increase of blended cements (CEM II, CEM III etc., Fig. 5). Whereas these new blends are suitable for achieving strength similar to Portland cement, thus can be used to build concrete structures, their long-term durability when used to make the final product concrete is far less established. The key durability challenge
